ARL-STRUC-TM-550

Aircraft Structures Technical Memorandum 550

**FATIGUE TESTING OF A FLOOR ANCHOR SPECIMEN**

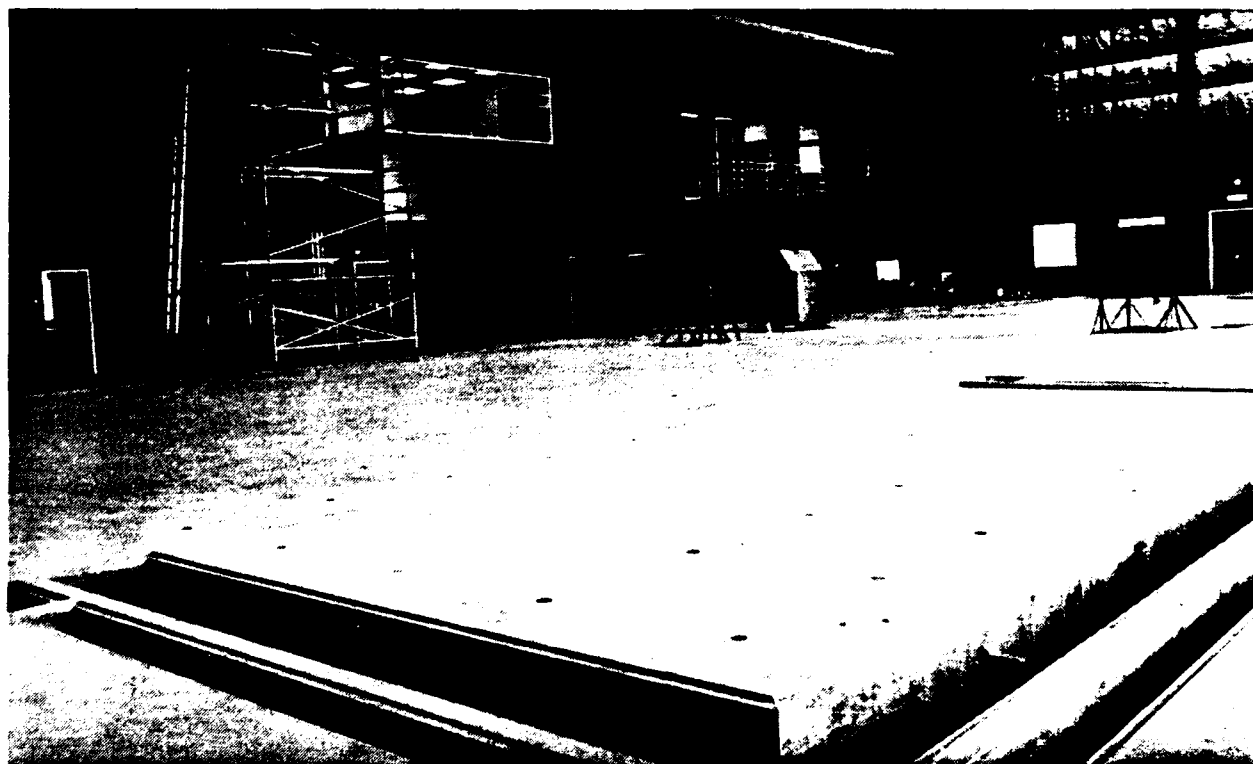
Fig. 2 Strong Floor

The strong floor slab (Fig. 2) located in the STL incorporates screw-threaded socket anchors (Figs. 3-5) used to restrain static and dynamic loads from test rigs. Threaded studs can be screwed into the sockets and used to clamp rig members to the floor.

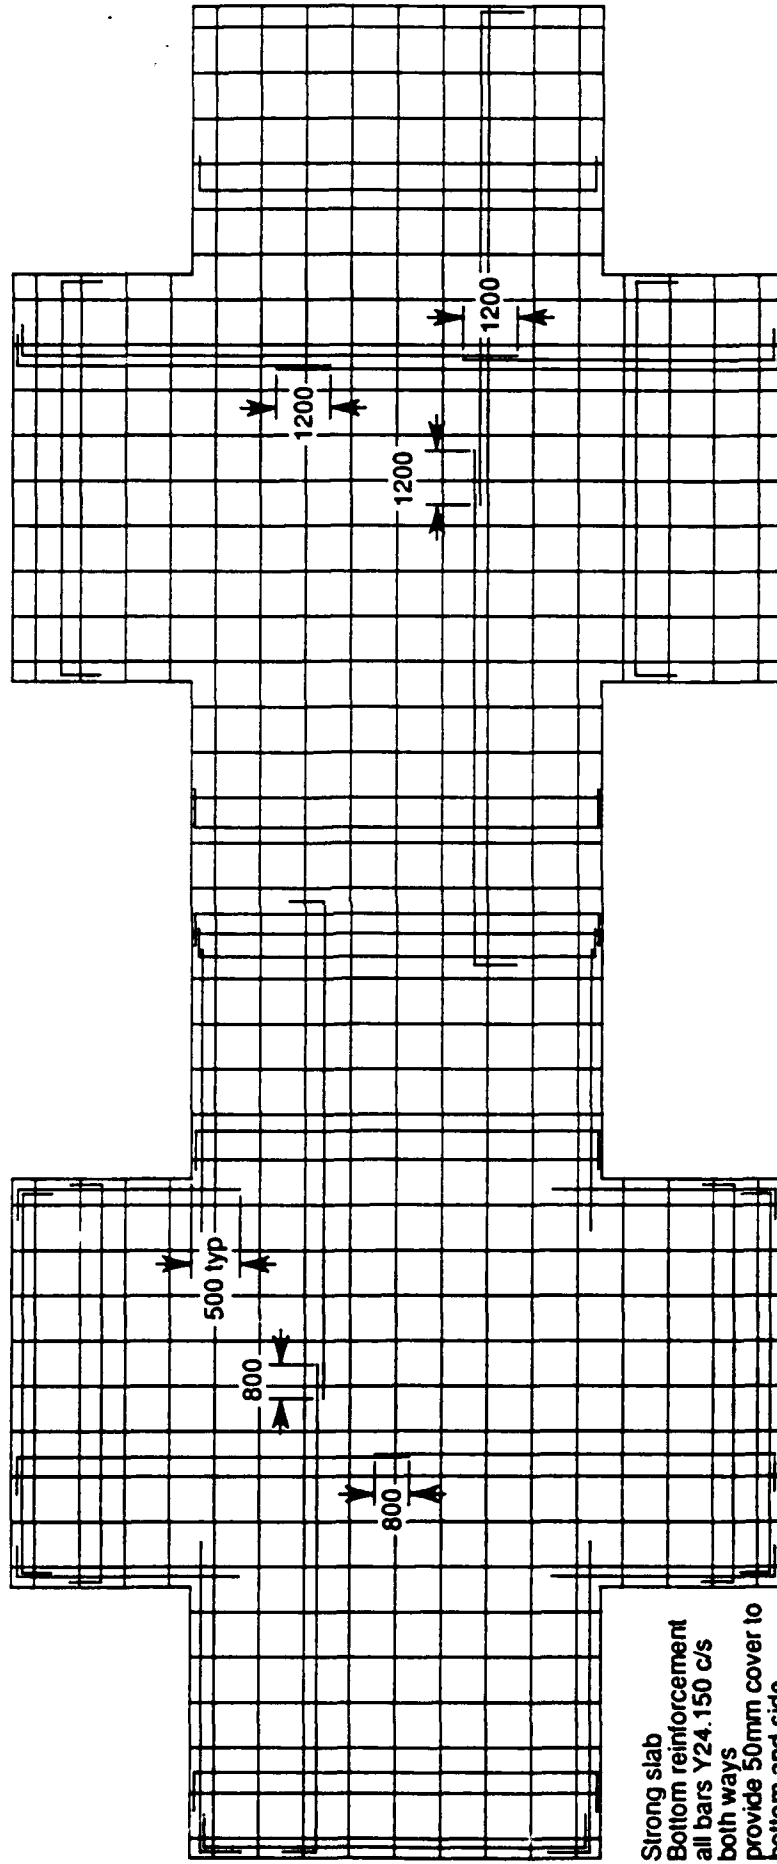
FIG.4 FLOOR ANCHOR ARRANGEMENT

The arrangement of the anchors in the strong floor slab is shown in Figure 4. Typical spacing of anchors is 1000 mm. Details of the cast-in anchor are shown in Figure 5. It comprises an internally threaded socket 170mm long, which finishes flush with the surface of the floor. An anchor rod, 900mm long, is screwed into the bottom 50mm of the socket and penetrates through to the bottom of the 1m thick slab. The stud to anchor rig members then screw into the top 90mm of the socket. All components are of galvanised mild steel and a 36mm metric thread size is used throughout. The floor anchor is not connected to the slab reinforcement but relies on a flange near the base of the anchor rod to hold it in the concrete. The test specimen was fabricated from a spare anchor assembly and surplus materials used in the construction of the strong floor.

Strong slab  
Bottom reinforcement  
all bars Y24.150 c/s  
both ways  
provide 50mm cover to  
bottom and side

Side face reo  
All bars Y20-200c/s horiz

Strong slab  
top reinforcement  
All bars Y24.150 both ways  
provide 30mm cover to top  
50 cover to side

batch as the strong floor was poured into the specimen assembly. The enclosed area around the anchor was square in cross-section with a side length of 300 mm. The specimen size was limited to a manageable weight and for clearance in the testing machine. The specimen was designed to locally represent the STL floor anchors, surrounding concrete and reinforcement as closely as possible. However, because of a late change to the design of the STL strong floor reinforcement, the reinforcement in the specimen was of lighter gauge but more closely spaced than in the strong floor. Y20 reinforcement rods at 100mm grid pitch were originally specified for the slab, but were changed to Y24 rods at 150mm pitch.

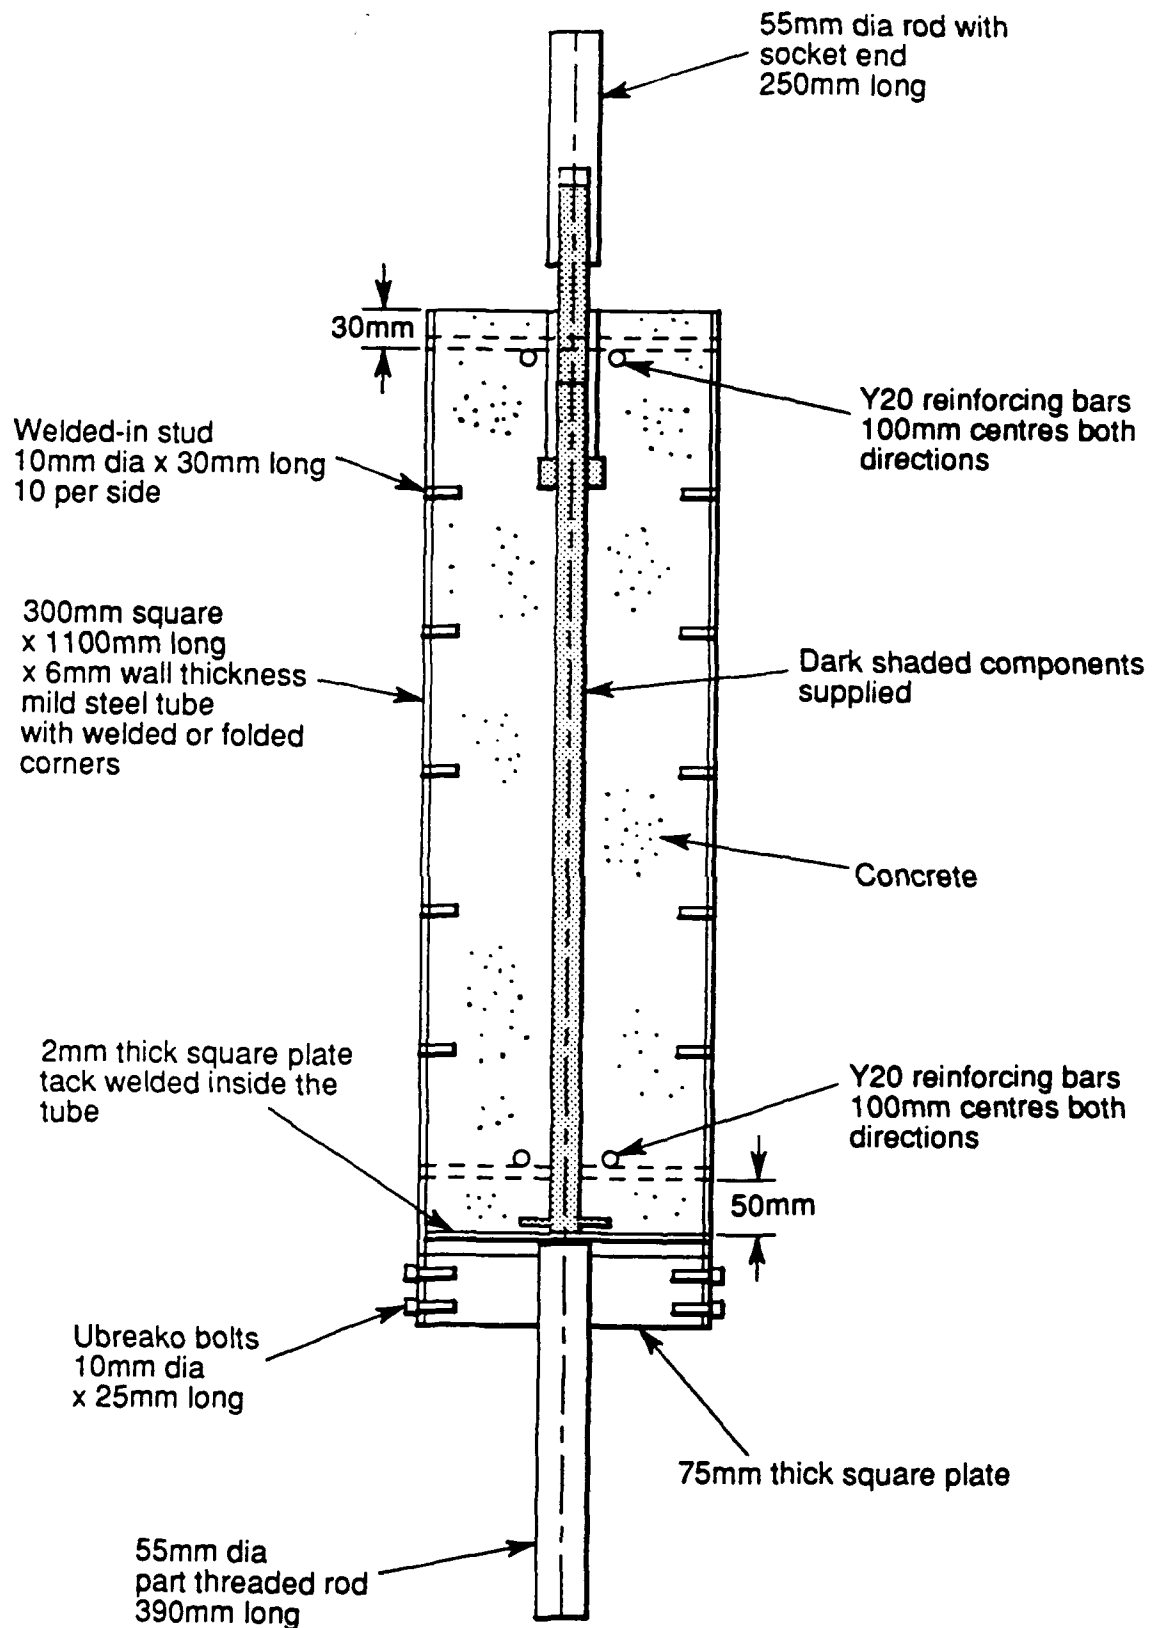
FIG.6 FLOOR ANCHOR SPECIMEN GENERAL ASSEMBLY.

Figure 6 shows the floor anchor specimen assembly. To contain the anchor for this test, a mild steel casing was constructed (Fig. 7) into which the anchor and associated reinforcing bars were fitted (Fig. 8). Subsequently, concrete from the same

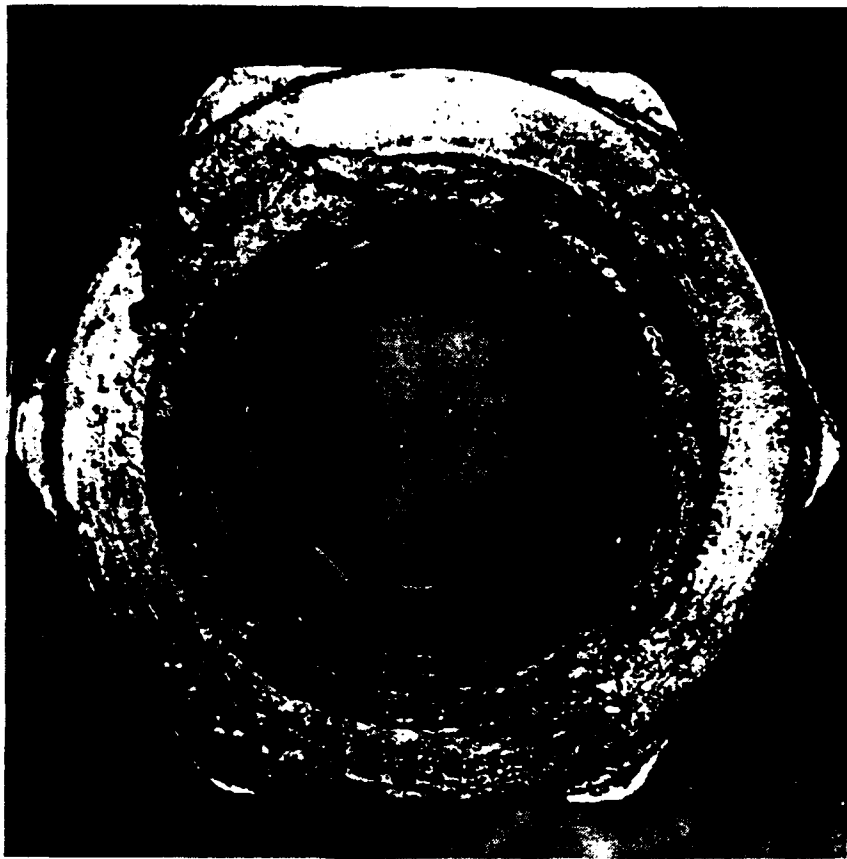
Fatigue testing was stopped. Visual inspection revealed no sign of failure or cracking. The static strengths of the stud and anchor were determined. In the first test the stud failed under a tensile load of 417.4kN and elongated by over 20mm. The failure occurred through the thread root just outside the end of the socket. The stud was then replaced with a high tensile steel stud and the test was repeated. This time the anchor rod failed just below the socket, and the socket and a short length of the anchor rod broke out of the concrete, causing significant spalling of the surrounding concrete and exposing the reinforcement rods (Fig. 11). Failure of the anchor rod was recorded at a tensile load of 502kN. The anchor rod elongated approximately 15mm. Both fractures are shown in Figure 12.

Fig. 12a Stud fracture surface

Fig. 12b Anchor fracture surface

In the residual strength testing, the anchor assembly exhibited good overload protection characteristics, in that the stud failed first. The stud is a removable and readily replaceable component.

The 20% reserve strength of the anchor rod over the stud is a good feature and should be preserved. If high strength steel studs are used, they should be appropriately waisted down so that they fail at a tensile load of approximately 420kN.

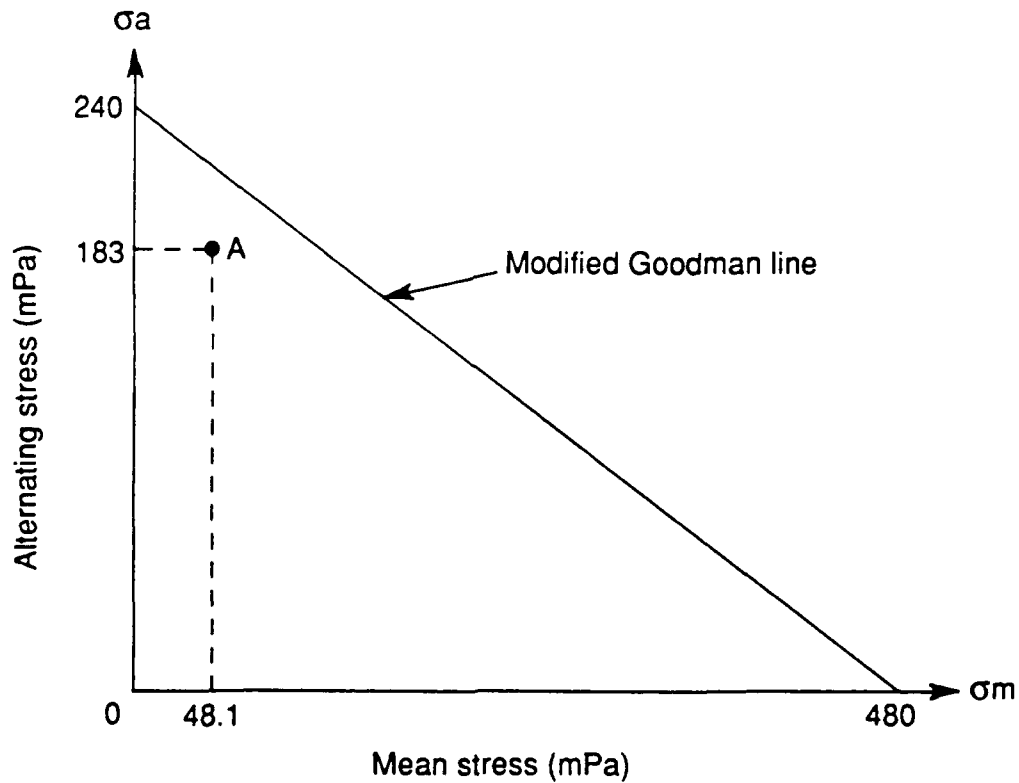
FIG.A1 FATIGUE DIAGRAM.

The following is a fatigue calculation for the stud-socket arrangement without the influence of the surrounding concrete. The stresses are plotted on a fatigue diagram (fig. A1).

A plot of the stresses (point A) shown in figure A1 indicates that the stud-socket arrangement is safe.

$$\sigma_m = \frac{49000}{1018} = 48.1 \text{ MPa}$$

$$K\sigma_a = 3.8 \times \frac{49000}{1018} = 183 \text{ MPa}$$
